SEDIBENG REGIONAL SANITATION SCHEME

Progress Report for the Department of Water and Sanitation (DWS)
for the Vaal River System Intervention (Refurbishment Works)
Period Ending – 31 December 2021

Document No.: J39079-03-G1-MPR04

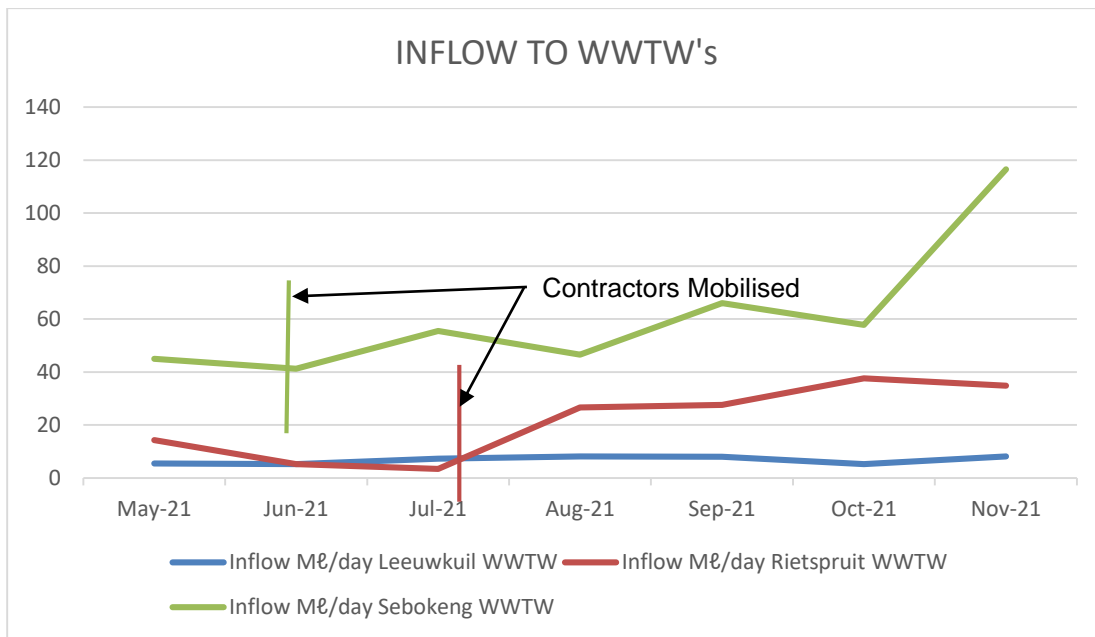
Figure 9: Inflows to WWTW's

From the data received, the inflows to Rietspruit WWTW is close to capacity. Due to community members rendering the WWTW's inaccessible, data is not readily available but it can be seen that inflows to Sebokeng WWTW have increased to 75% of the Works' capacity since the unblocking operations of the bulk lines feeding the WWTW from the north has commenced. Data has been received for the period 13 December 2021 to date but are lower, possibly attributed to blocked screens at the intake works. Latest indications are that the inflow to Sebokeng WWTW's are in the order of 126

Based on Table 8 and as indicated in Figure 9 below, the impact of the mobilisation of the Contractors illustrates that the unblocking interventions to date have initially resulted in a decrease in network spillages and better containment of the sewage flows feeding into the WWTW's. However, it must be noted that the refurbishment of the three WWTW's infrastructure is urgently needed to effectively treat the incoming flows.

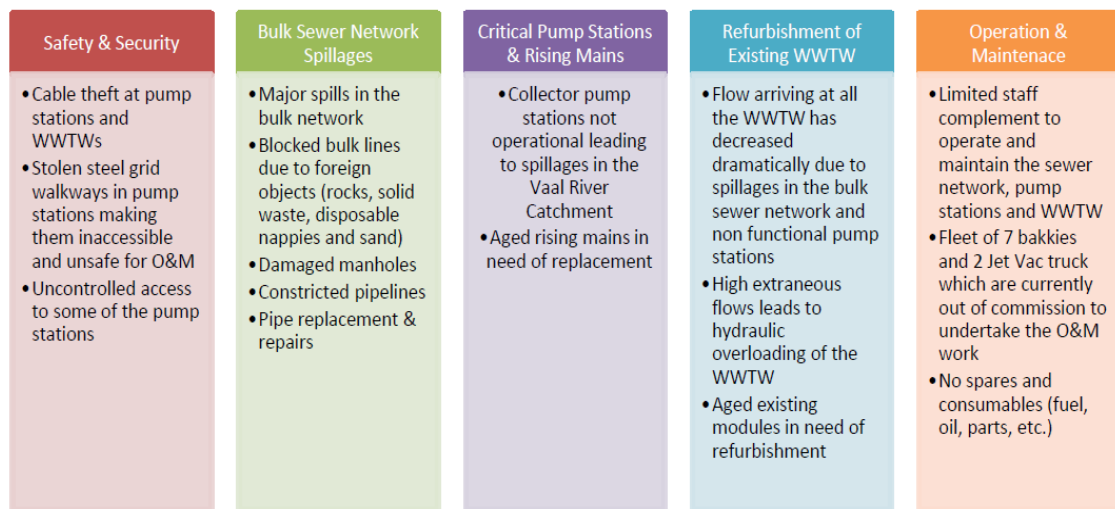
Figure 1: Components of the Vaal River System Intervention Programme

The purpose of the Vaal River System Intervention (VRSI) Programme is to resuscitate the existing wastewater collection, conveyance, and treatment infrastructure, returning it to an operational state, thus eliminating and preventing the further pollution of the Vaal River system. The components of the scope of works are summarised in Figure 1 below.

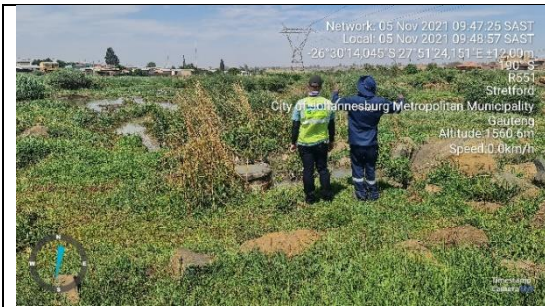
- North, on the boundary of Orange Farm / R551, the DN900 (400 m length) line reduces to a DN675 line - approximately 150 m in length. Just south of the R551 at the first manhole, a spillage is currently occurring on the DN900 due to capacity constraints and narrowing of the pipe. This is causing a Hydrostatic block in the 900 line with the resultant spillage. (Refer Figure 3);

-
- Because of the flow, the subsidiaries are unable to drain into the bulk line due to the hydrostatic pressure and may cause further blockages in the adjacent neighbourhoods and lines. This is evident from the callouts received;

Figure 3: Spillage at R551

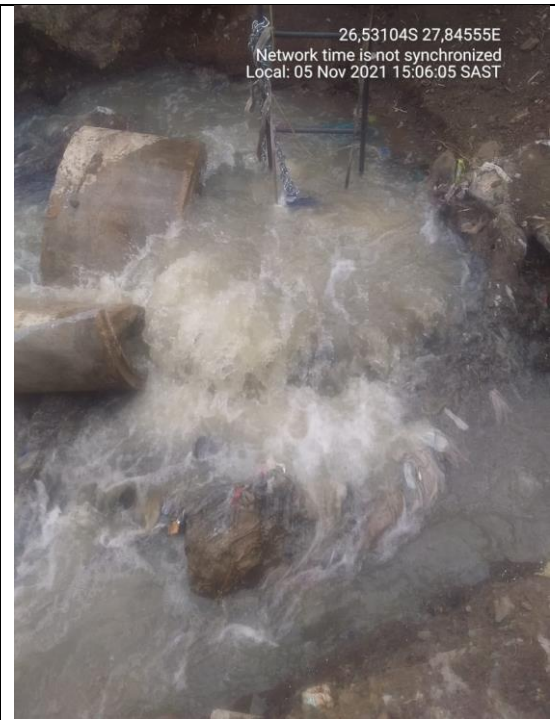
- Were the two (2) DN600 pipelines (Vlei and Rescue Line) join downstream into a DN900 line, the DN900 is unable to deal with the flow, as stated above and constant repair and work done on the said line in the Evaton SAPS area due to the hydrostatic pressure causing manholes in both lines to “pop”;

Figure 4: "Popped" Manhole Upstream of Rescue Site due to Overpressured Line

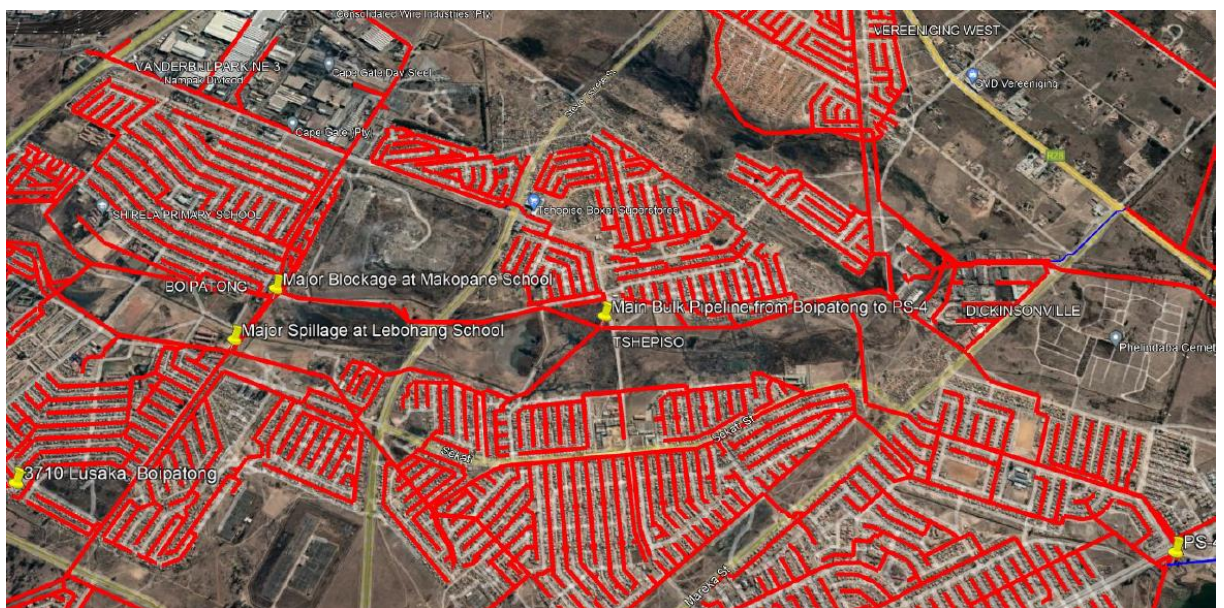
Figure 6: Boipatong - Tshepiso - Sharpeville Main Outfall Cleaning

Observations:

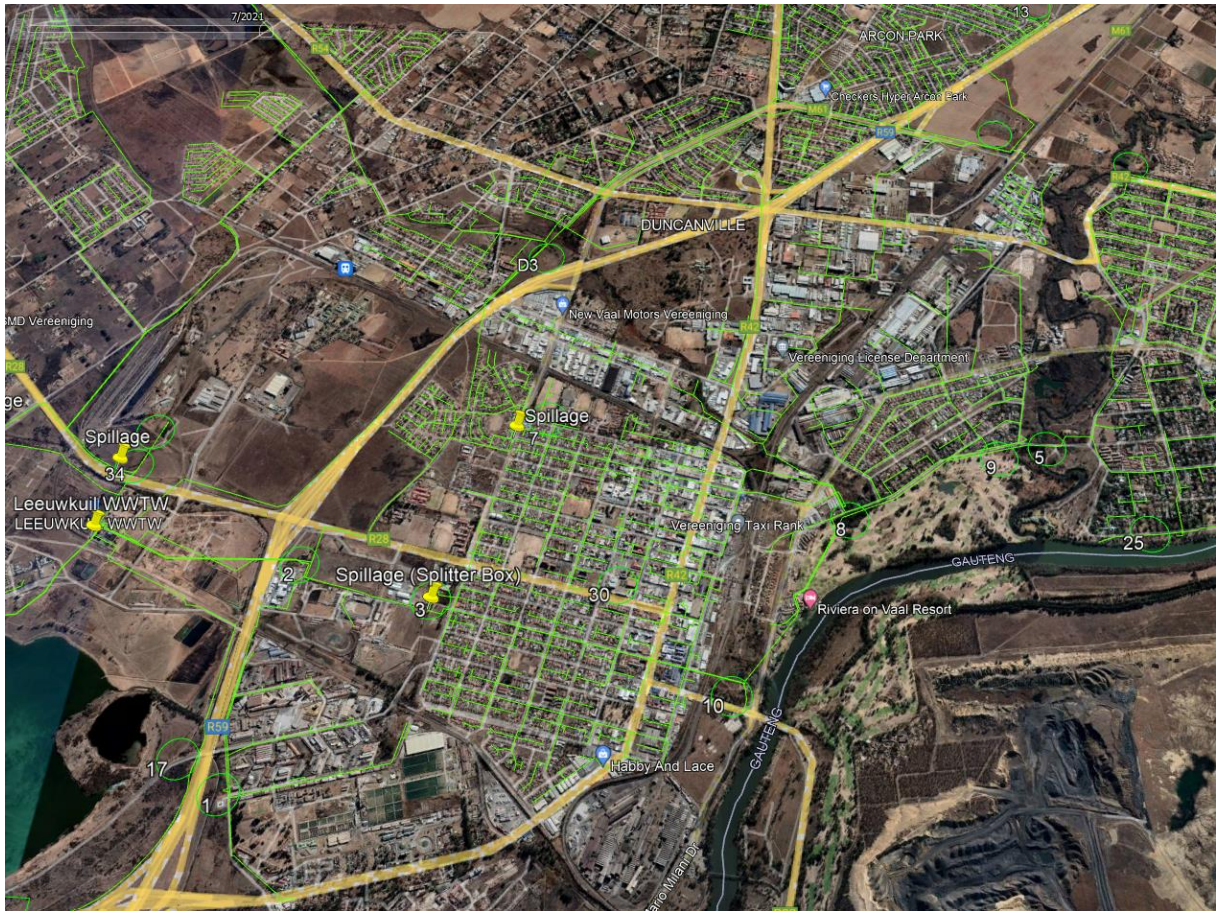
Figure 7: Spillages in Leeuwkuil Catchment

- The DN250 line in Union Street was blocked near the corner of Livingstone Street. As the infrastructure is old, intervention to unblock the line was carefully coordinated with ELM representatives. It was suspected that the line has collapsed. Following unblocking operations, a CCTV inspection was conducted on 17 November 2021 which confirmed the pipe collapse. The pipeline is in excess of 6 m deep and reportedly located in collapsible soils. The resulting spillage cannot be managed as explained further below; and
- The occurrence of collapsed pipelines is causing spillages at various locations i.e. at the PS 8 splitter box as well as the splitter box near PS 3. Please refer to Figure 7 below.

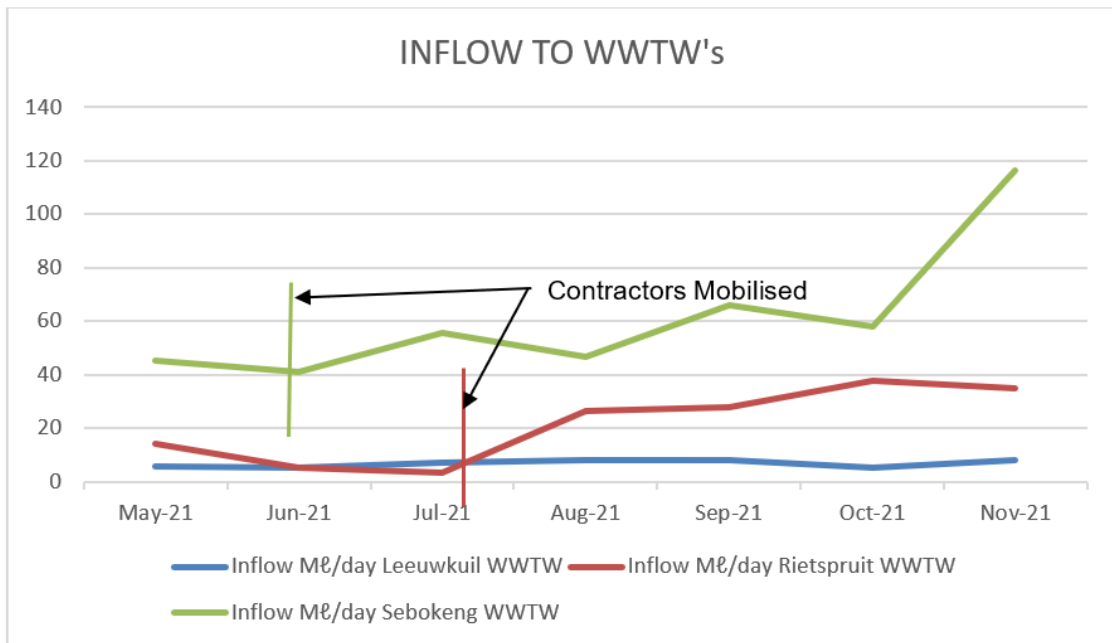
Figure 9: Inflows to WWTW's

From the data received, the inflows to Rietspruit WWTW is close to plant capacity. Due to community members rendering the WWTW's inaccessible, data is not readily available but it is can be seen that inflows to Sebokeng WWTW have increased to 75% of the Works' capacity since the unblocking operations of the bulk lines feeding the WWTW from the north has commenced. . Data has been received for the period 13 December 2021 to date but are lower, possibly attributed to blocked screens at the intake works. Latest indications are that the inflow to Sebokeng WWTW's are in the order of 126

Based on Table 8 and as indicated in Figure 9 below, the impact of the mobilisation of the Contractors illustrates that the unblocking interventions to date have initially resulted in a decrease in network spillages and better containment of the sewage flows feeding into the WWTW's. However, it must be noted that the refurbishment of the three (3) WWTW's infrastructure is urgently needed to effectively treat the incoming flows.
